Engin Mardin,
Yacht and Small Craft Surveyor.

PRE-PURCHASE SURVEY REPORT

SY [REDACTED]

Beneteau Oceanis [REDACTED]
2019 model

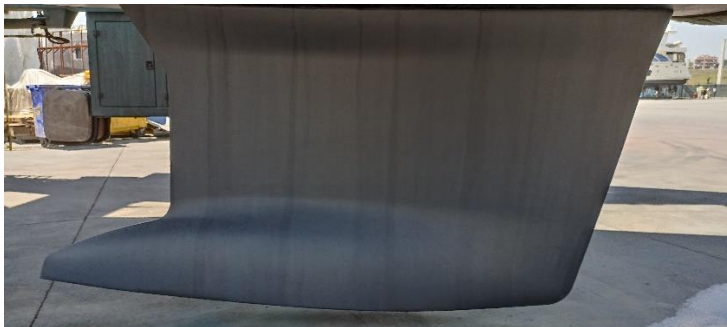
1

Cast Iron Keel (magnetic) (1) sighted from various angles, was newly painted and seem vertical and in relation with the hull. One minor stain observed at the very aft end of the keel (2). Length of the keel from the hull was measured as 155 cm. The bottom of the keel inspected but only the new antifouling paint could be seen. No deflection observed around the keel root. Hammer test around the keel from outside was sharp. Keel was attached through 11 stainless steel studs with nuts, washers and backing plates. The first connection from the rear was showing rust stain under the backing plate (3), this area was damp, and the next grid was consisting of the bilge well this area was damper, the keel studs, nuts and backing plate bottom at the well was even more rusty (4). The rust scrapped end shiny stainless steel was seen. No internal seepage was detected. Nu u-cup shape or distortion observed on the washers, no visual damage or debonding observed in the bilges, minor gelcoat cracks seen (5).

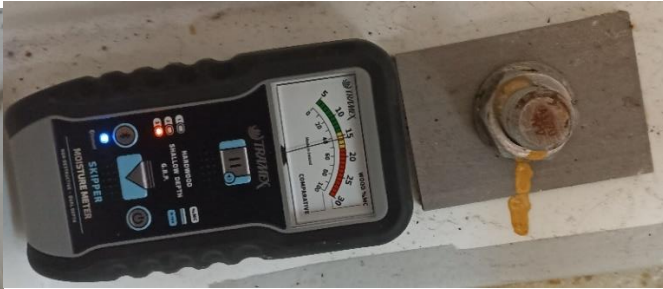
6

Moisture readings were taken around 40 (6) in comparative mode when the boat was hauled out where it was expected to be lower. Hammer test around the keel root did not suggest any delamination, no repairs has seen.

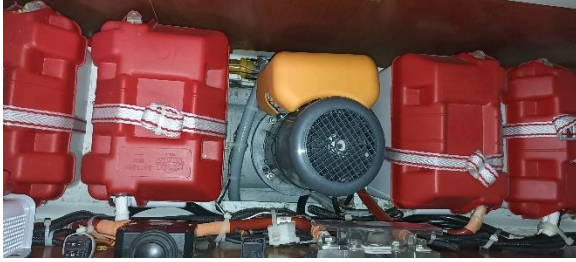
1

Bow thruster area (1) could be reached under the bed of the fore cabin. There was a bilge pump at the fore of the bow thruster and salty water seen at the beneath of the bilge between the inner moulding and the hull. The same area inspected from outside and it was seen that the water was dripping from the port side bow thruster tunnel laminate from the very first moments of the boat was hauled out, same dripping (3) also observed 24 hours later.

The seawater source observed at the bow thruster area should be explored and water ingress should be prevented. The laminate around the area should be dried. Bilges should be dried and ventilated. In the next haul out it is recommended to repeat the above underwater tests to be compared with the results.

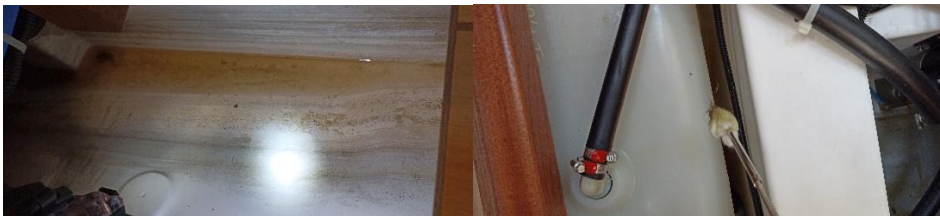
The bilges at the starboard side under the boiler was wet (4), the port side under the extra fuel tank was wet by fuel (5). As mentioned in the pervious section the keel stub was wet. Fore of the engine was wet around the intake vales.

*******Fuel in the bilge under the extra fuel tank should be cleaned. *******

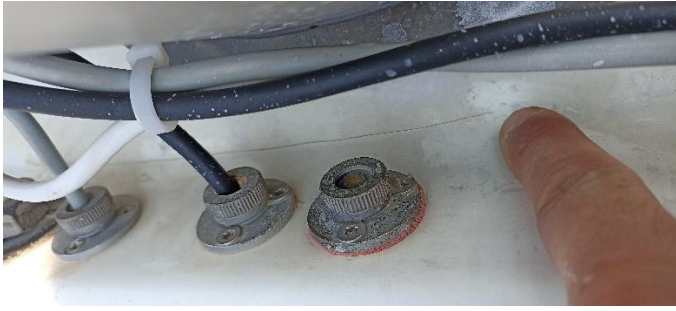
1

Coach roof was original nonskid fiberglass, cosmetically good condition, mast was stepped on the coach roof, aggressively swigged and no movement observed. No significant gel coat cracks observed except a minor one (1).

Gelcoat repair would be prudent. Arch was a load bearing area therefore should be traced periodically.

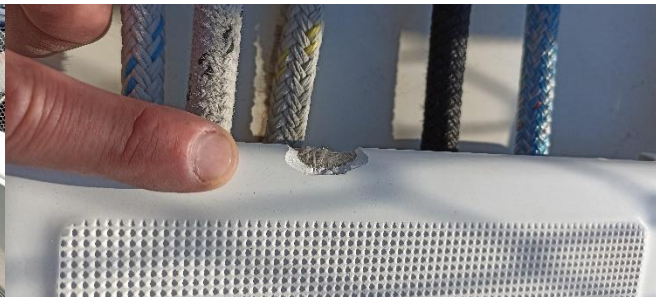
2

Cockpit table was in good condition. Cockpit locker gasket should be fixed (4). Small gelcoat cracks observed on the high traffic areas (2). At the starboard quarter stain was observed (3), this reason was presumed to be from the shore power cable that submerged into the foul marina water for a long time and stain happened when the cable collected on to the deck.

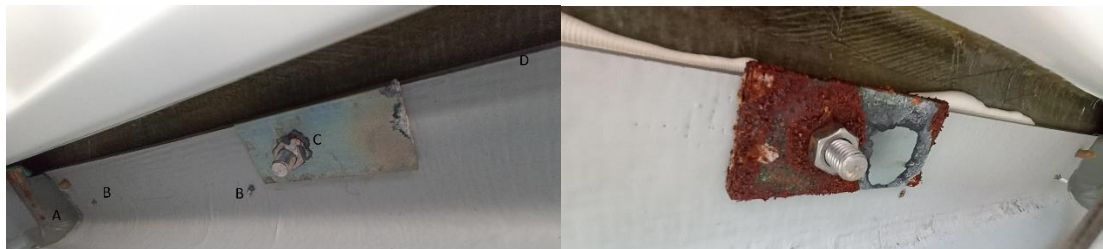
seen from the inside of the skipper cabin and the pool area lockers. **Port side stanchion backing plate was showing corrosion (2), this was presumed to be a crevice corrosion, this plate should be made good or changed from new and wax should be applied for corrosion prevention.** Moisture meter or hammer test could not be applied due to the linings from inside, above the linings there was no stain or seepage observed. Safety net was seen between the stanchions, and they were rigged with the help of the many screwed hooks (3) to the toe rail, **metal in the wood will lead to an inevitable corrosion therefore it is recommended to remove those hooks from the toe rail and the holes should be appropriately filled.** All stanchions were checked by hand found satisfactory.

(2) Starboard side stanchion connection

d7. Port side stanchion plate was showing corrosion (2), this was presumed to be a crevice corrosion, this plate should be made good or changed from new and wax should be applied for corrosion prevention. Metal in the wood will lead to corrosion therefore it is recommended to remove those hooks from the toe rail and the holes should be appropriately filled.

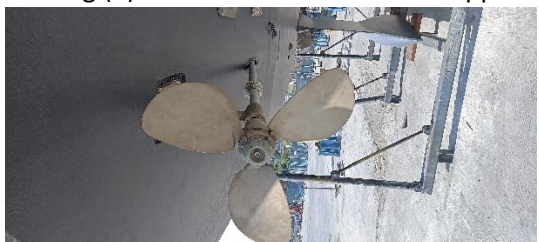
1

The boat was fitted with Flexofold right-handed 3 blade bronze folding propeller (1), there was no damage or corrosion observed on the propeller. Propeller was tested by hand and it was secured on shaft. No ply observed on the Cutless bearing (2) or at the A bracket shaft support.

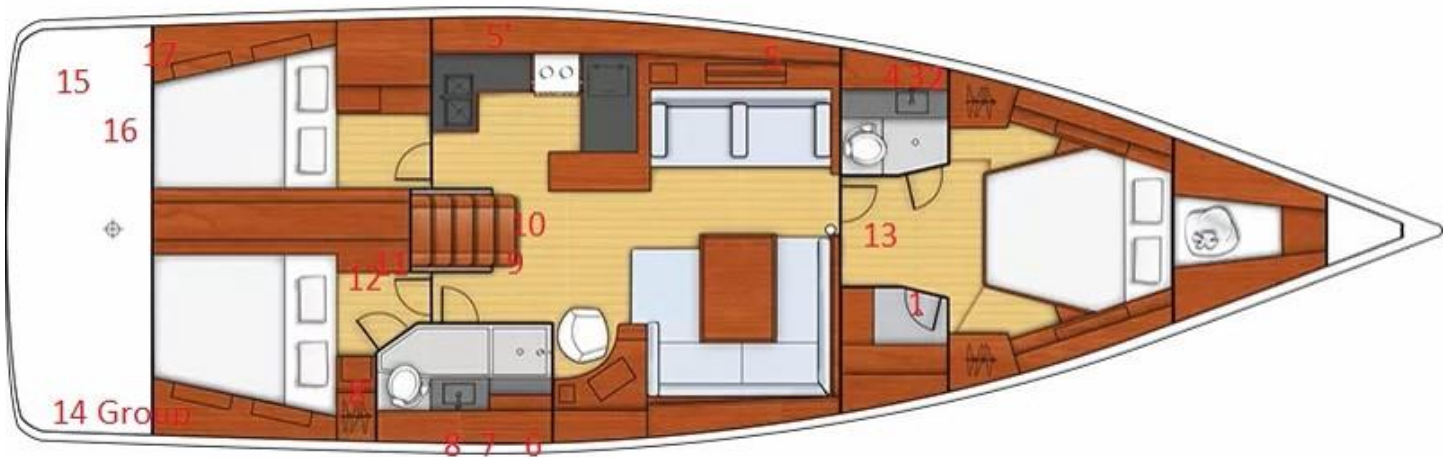
- 1: Shower Drain
- 2: Shower Drain
- 3: Sink Drain
- 4: Wc Flushing inlet
- 5: Wc outlet
- 5': Galley sink drain: Extra green corrosion.
- 6: Wc outlet
- 7: Sink Drain: Could not opened and closed.
- 8: Shower drain: Could not opened and closed.
- 8': Wc inlet
- 9: Air conditioning sea water inlet: **Seepage seen beneath the valve. (1)**
- 10: Generator seawater inlet
- 11: Shaft cooling
- 12: Engine inlet seacock
- 13: Transducer
- 14 Group: Automatic bilge pump, bilge pump, AC outlet:
- 15: Generator exhaust water
- 16: Generator drain
- 17: Engine exhaust (above waterline)

Most of the valves were opened and closed to full extent and was in working order. Most of them were screwed with double clips. **Engine and generator seawater hoses were old and they must be renewed.** The valves arrangement as could be seen from inside was at some part bronze and DZR brass. From outside some valves were inspected by snake camera

In conclusion all valves and skin fittings should be dismantled, inspected, cleaned, and changed with new if found necessary. Underwater plastic skin fittings advised to be replaced with DZR brass or bronze.

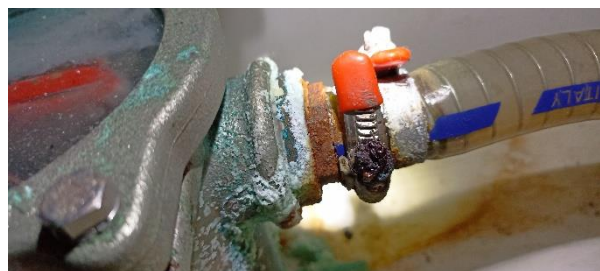
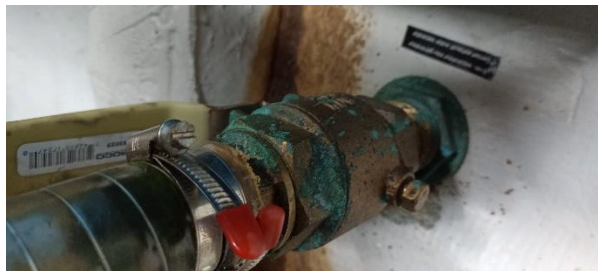
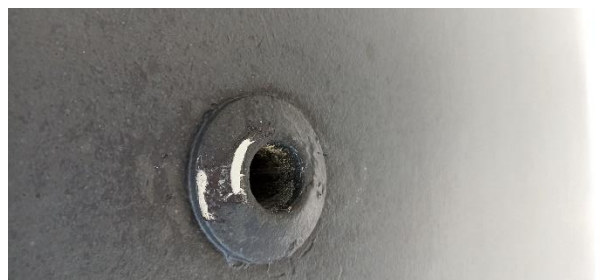
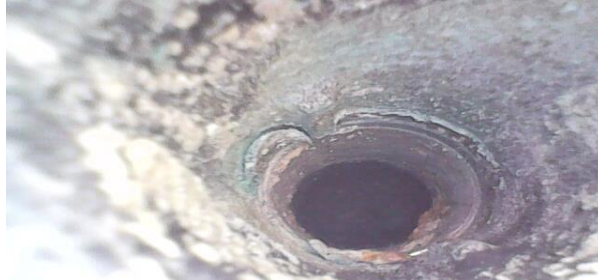
(4). Skin fittings were painted with antifouling, for sampling I have scrapped two of them and found that they were plastic (3) at the starboard side underwater part. **Ac inlet, Ac inlet filter (1) and genset sea water intakes (2) needs immediate attention.**

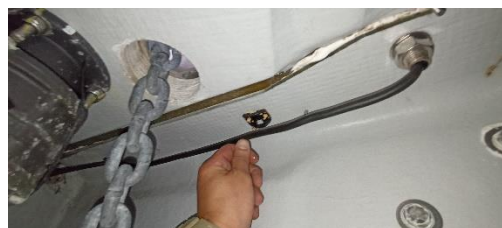
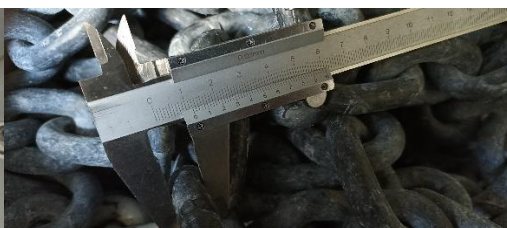
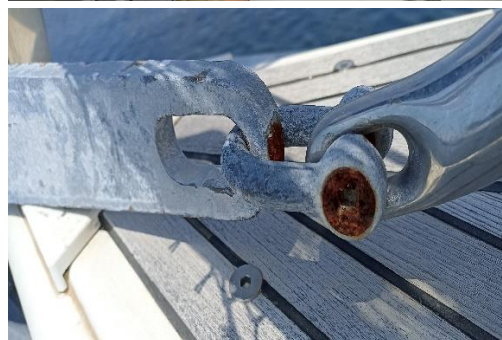
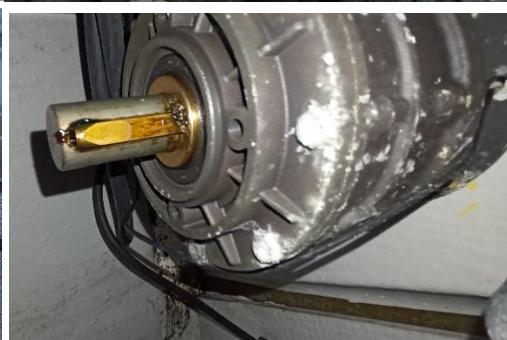
The boat was equipped with a Lewmar vertical windlass and galvanized Delta anchor, the weight of the anchor could not be red, connected to a chrome swivel with a shackle. **The shackle pin was corroded (3) this should be changed with the new one.** Other side of the swivel was linked to the 12 mm galvanized chain (2). Chain was not laid and checked link by link.

Electric cable support should be fixed (1). Anchor base from inside was free from gelcoat crack. Chain locker was dry as could be seen from above.

Windlass, anchor remote from helm station, chain counter and the cable controller at the chain locker tested at the sea trial and found in working order. **In the absence of the service record it is recommended to service the windlass (4) before use.**

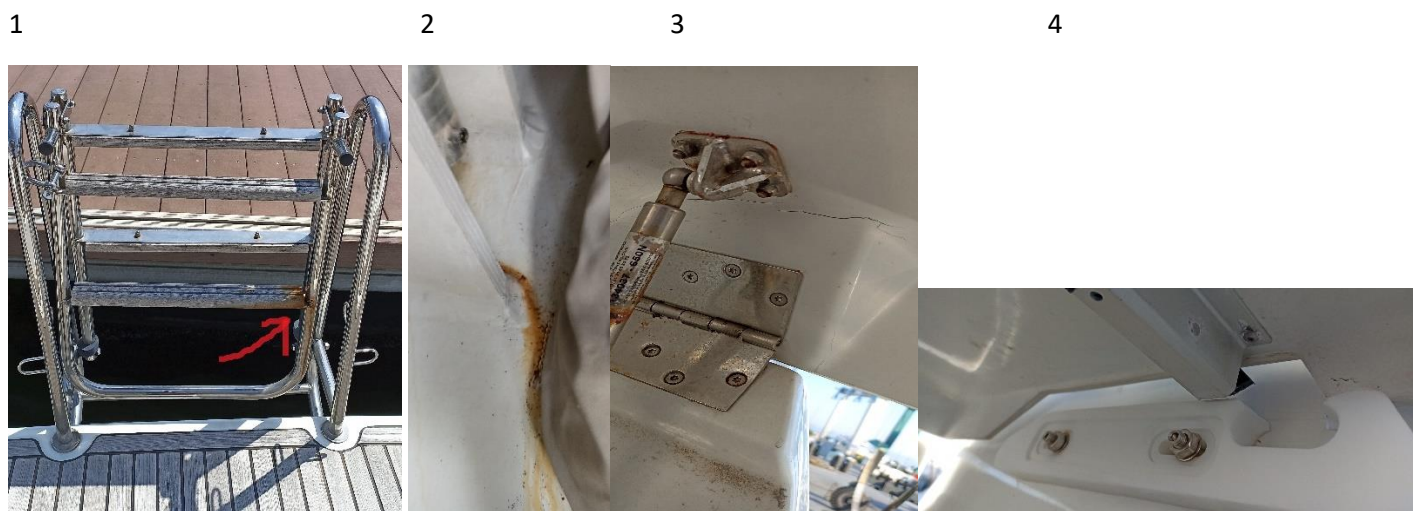
The sea ladder was showing minor corrosion (1), this should be made good, it was not opened and tested, connection points to the electric platform was not showing significant gelcoat crazing.

The electric platform opened and closed both from the wheel panel control and the remote control. It was seen that the starboard side was not fitting properly (4) when closed position also when looked from inside the piston was showing minor corrosion and a stress crack seen under the bench of the platform.

f6. The sea ladder was showing minor corrosion (1), this should be made good. Davits water intake to the lockers should be prevented. Rear lockers should be dried. Electric platform starboard side was not fitting properly (4).

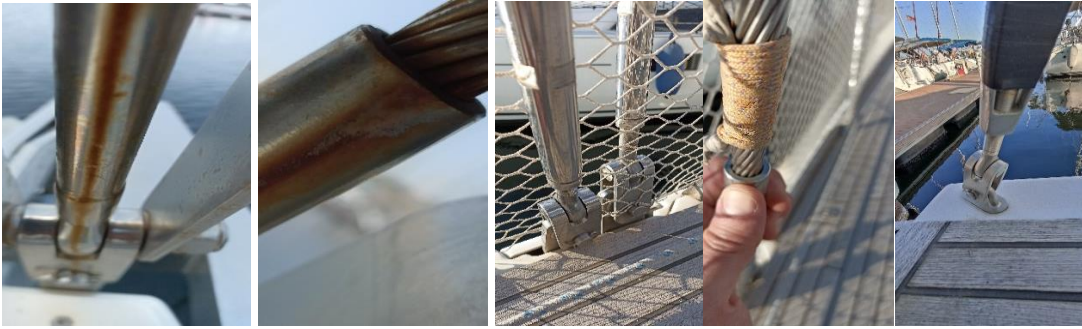
1

Rust stain seen on the fore stay swage (1), other articulations at the toggles and turnbuckles were showing minor rust stains, those should be cleaned and polished as a preventive maintenance. No broken strands observed on the wires from deck level. Small rope wrapped (2) on to the port shroud should be removed, back stay terminals were taped (3) they should be removed, because they may help to develop corrosion.

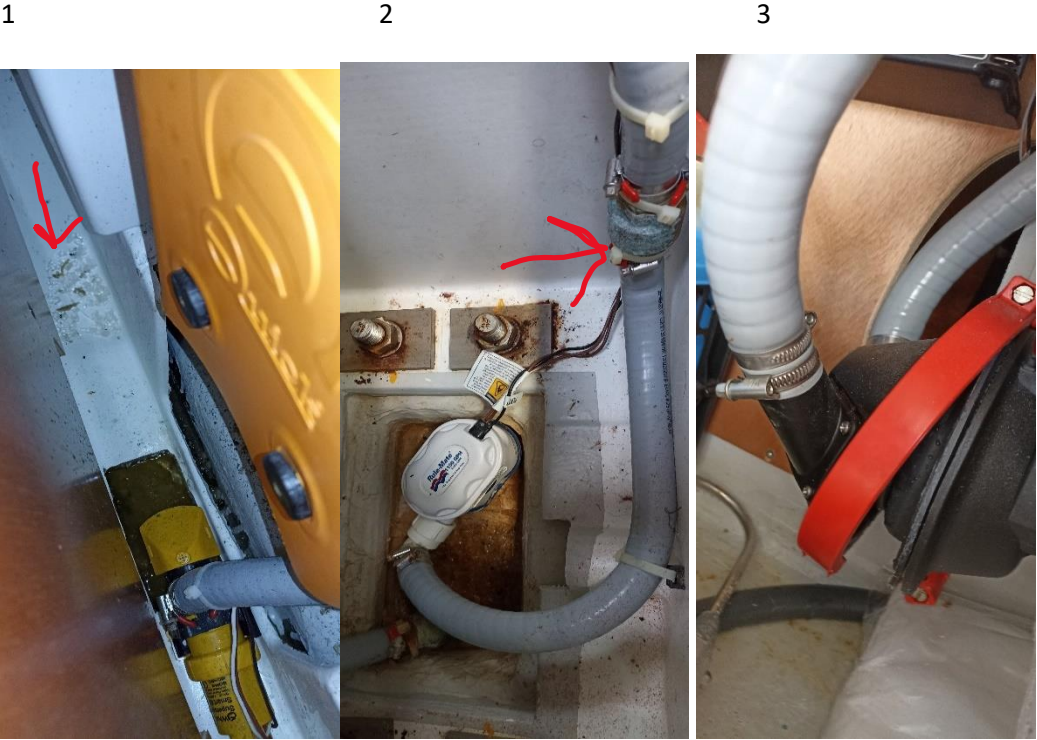
Bilge pumping arrangement was from original. There were two electric and one manual bilge pump. The one at the bow thruster area and at other was placed at the keel well were electric bilge pumps. Electric bilge pump switch turned on from the electric panel and the electric motor sound heard however no waterflow could be seen where there was not enough water in the bilge well. The manual pump was placed at the starboard side pool area, it was tried but the red bracket was unscrewed (3). There was broken glass pieces at the bow electric bilge pump (1), the bilge hose connector was corroded (2).

The glass pieces should be cleaned from the bow electric bilge pump. Hose connector corrosion should be cleaned, and the manual bilge pump should be fixed.

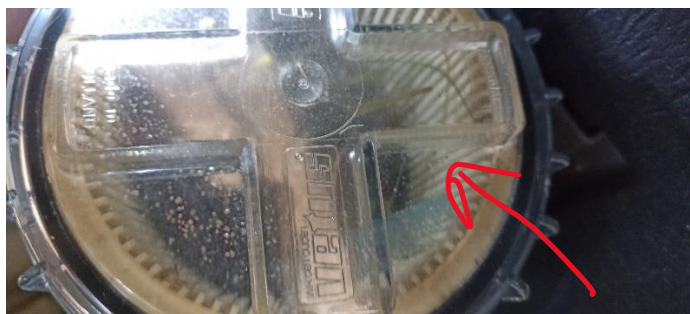
3

functioning condition. When first started from the generator control “service interval run out” message popped up. Generator working hour was 358.9 hour. **The generator seawater plastic filter was full of seaweed, the filter (3) should be cleaned, and the filter is advised to be changed with a metal filter which is better for the engine room installation. The related seawater intake valve was also defective, water seen at the perimeter. The related hose was also old and should be changed. It is prudent to change all seawater related hoses on boat. (Heads, machinery etc.)**

J5. The generator seawater plastic filter was full of seaweed, the filter (3) should be cleaned, and the filter is advised to be changed with a metal filter which is better for the engine room installation. The related seawater intake valve was also defective, water seen at the perimeter. The related hose was also old and should be changed. It is prudent to change all seawater related hoses on boat. (Heads, machinery etc.)
