Engin Mardin,
Yacht and Small Craft Surveyor.

PRE-PURCHASE SURVEY REPORT

SY [REDACTED]

Beneteau Oceanis [REDACTED]
2019 model

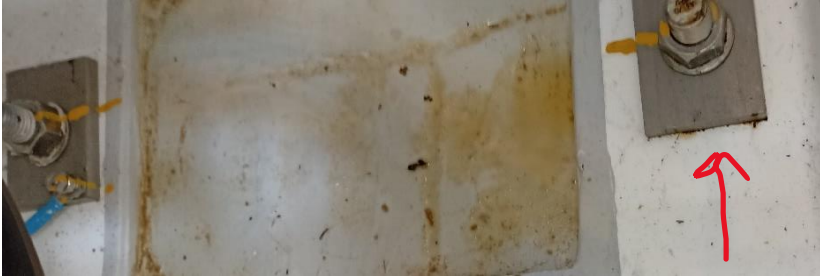
3

Cast Iron Keel (magnetic) (1) sighted from various angles, was newly painted and seem vertical and in relation with the hull. One minor stain observed at the very aft end of the keel (2). Length of the keel from the hull was measured as 155 cm. The bottom of the keel inspected but only the new antifouling paint could be seen. No deflection observed around the keel root. Hammer test around the keel from outside was sharp. Keel was attached through 11 stainless steel studs with nuts, washers and backing plates. The first connection from the rear was showing rust stain under the backing plate (3), this area was damp, and the next grid was consisting of the bilge well this area was damper, the keel studs, nuts and backing plate bottom at the well was even more rusty (4). The rust scrapped end shiny stainless steel was seen. No internal seepage was detected. Nu u-cup shape or distortion observed on the washers, no visual damage or debonding observed in the bilges, minor gelcoat cracks seen (5).

Bilges should be dried and ventilated. Rust should be removed from the keel studs, when reached to the shiny stainless steel it is advised to be waxed as a preventive protection.

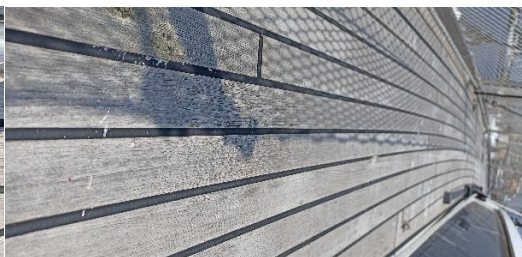
2

Teaks were serviceable condition (2).

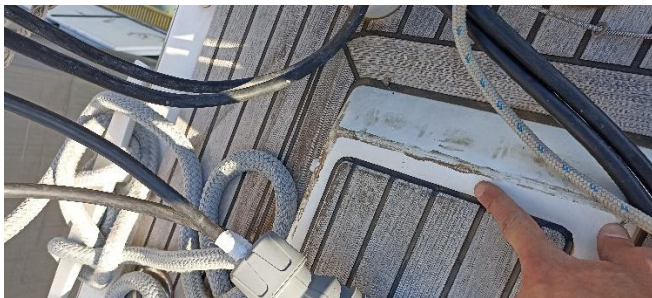
3

Cockpit table was in good condition. Cockpit locker gasket should be fixed (4). Small gelcoat cracks observed on the high traffic areas (2). At the starboard quarter stain was observed (3), this reason was presumed to be from the shore power cable that submerged into the foul marina water for a long time and stain happened when the cable collected on to the deck.

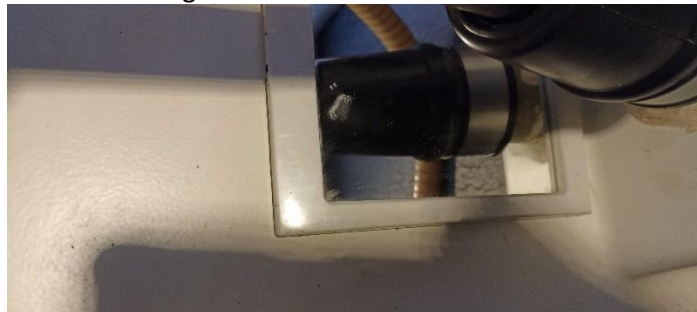
3

Output shaft right behind the coupling turned by hand and power applied from inside, visually inspected against corrosion no significant move or rust stain observed. Shaft coupling alignment was precise. The shaft was magnetic. Underside of the seal (3) was observed by mirror and no rust stains or damage observed. Stern tube hammer tested from inside and found secured. Same test applied from outside and no significant move observed at the Cutless bearing (2). No vibration detected during the sea trial.

Cutless bearing may need to be replaced in near future.

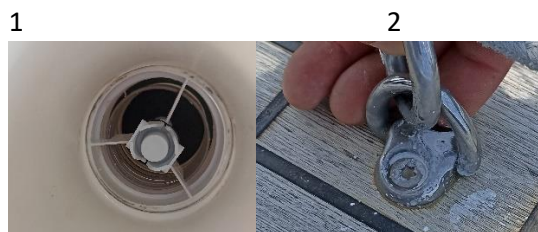
There were eyebolts (2) for lifelines on deck. And a cowl vent (1) on the castle between the saloon small hatches, opened and closed from inside.

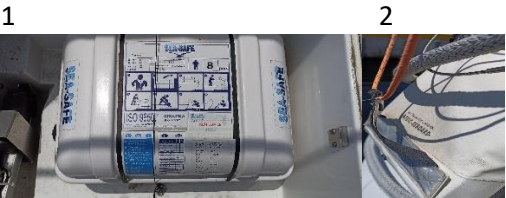
8 person life raft (1) was on board, located at the stern side. Next service was indicated as May 2023. Also there was a boarding ladder (2) located at the port side pushpit, not tested. Life raft service should be done.

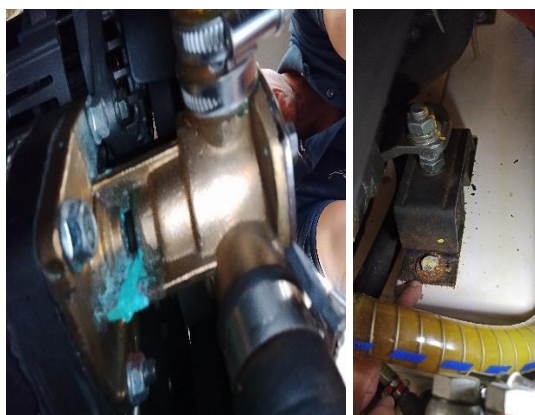
1

The engine was a Yanmar 4JH110 direct shaft with E52532 engine number (1). Engine work hour was 603.2 hours. Engine service invoices was not on the boat. General isolation of the compartment was good **except the threshold sponge, it was released, it should be bonded. Impeller was liking (4). One engine mounting that was under the impeller a the port side was corroded, this should be maintained.** Oil sump visually checked. **Engine raw water filter should be cleaned. Oil drip observed by the Yanmar service Mr. Levent between the crank seal and gear seal during the sea trial, this should be maintained. Discolored engine raw water intake hose should be changed with new.** Exhaust hoses and the muffler visually checked; no corrosion observed. Fuel injectors and the v belt was covered, not seen. Oil dipstick checked, viscosity was good, no visual debris has seen. Shift cables checked on the engine, was in good condition.

i1. Threshold sponge, it was released, it should be bonded. Seawater pump was leaking (4). One engine mounting that was under the impeller at the port side was corroded, this should be maintained. Engine raw water filter should be cleaned. Oil drip observed by Yanmar service Mr. Levent, between the crank seal and gear seal during the sea trial, this should be maintained. Discolored engine raw water intake hose should be changed with new.

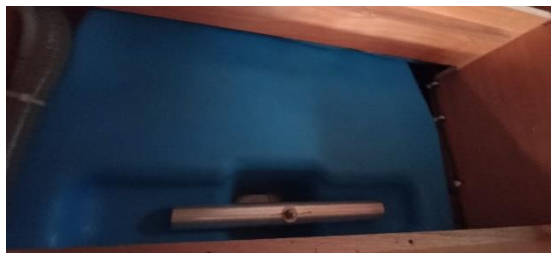
2

330L plastic freshwater tank placed under the fore cabin (1) bed, it was secured. Second freshwater tank was placed under the saloon table this could be seen under the starboard side sofa. Water tank valves (2) were placed at the starboard side under the sofa. Water pressure was in working order. Boiler was in working order. There was no grey water tank. City water could be able to be connected to the boat from the starboard helm station.

Fresh water system hoses will need to be replaced in the near future, discoloration observed.

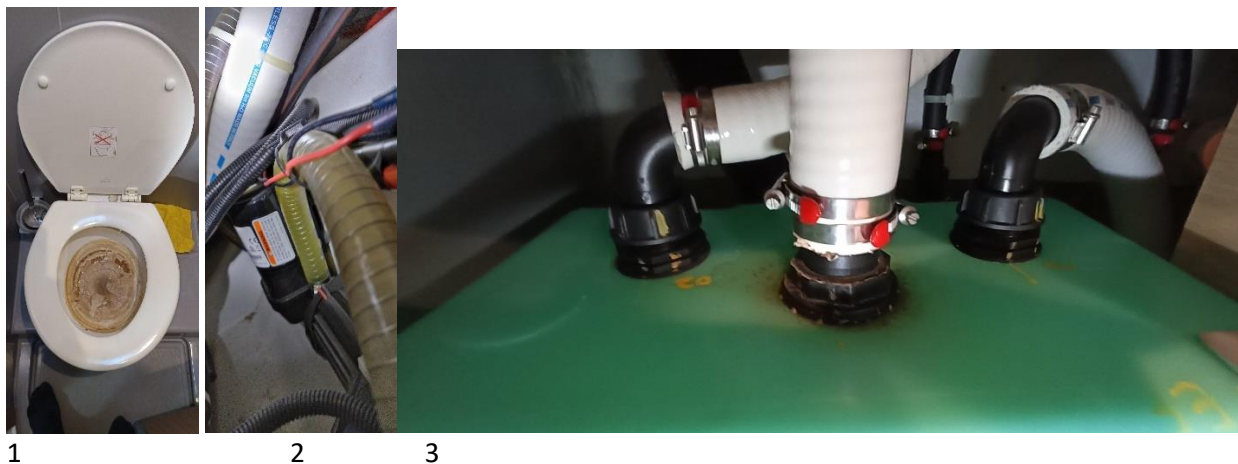
Wastewater tanks were 80 L plastic. Jabsco electrical toilets were fitted. No significant toilet odor felt. Toilet bowls were dirty (1). Holding tank (3) hoses were double clamped and secured. Electrical toilets were in working order. Toilet water intake was through pumps and the hoses were not doing gooseneck instead they were tied (2), since this arrangement is at the sea level a longer gooseneck which goes far above the waterline would be safer. The seawater intake hoses were showing discoloration. Shower drain pumps tested and they were all in working order.

Underwater intakes are advised to have gooseneck above the waterline. Seawater intake hoses will need to be changed in near future.

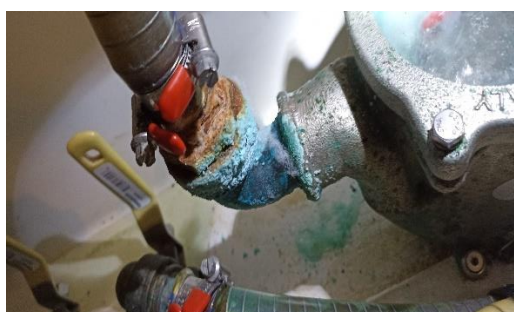
1

Domatic air conditioning (AC) seawater filter was corroded, this should be maintained or changed with new. The related seawater intake valve was also defective, the valve and the one next to it should be dismantled inspected and changed if found necessary, water seen at the perimeter of the valves. The related seawater hose was also old and should be changed. AC seawater pump outlet hose fitting was corroded, this should be maintained or changed (2).

j7. Domestic air conditioning (AC) seawater filter was corroded, this should be maintained or changed with new. The related seawater intake valve was also defective, the valve and the one next to it should be dismantled, inspected and
